REVISITING CLOSURE: ENVIRONMENTAL RESTORATION FOR SUSTAINABLE LAND UTILISATION AT ZWARTKOP CHROME MINE

S. Absolom¹ & D. Limpitlaw²

BHP Billiton and the Centre for Sustainability in Mining and Industry have embarked on a study to assess the process of transition from the old disturbed site to a new rehabilitated surface capable of sustaining economic activity. This paper scopes the challenges of best practice closure in South Africa today using Zwartkop Chrome Mine as an example.

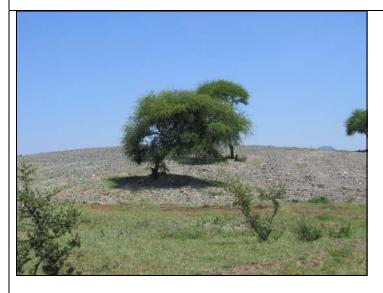
Figure 4. Rehabilitation of the No. 4 New Shaft area.

a. No.4 New Shaft, circa 1968.

b. The No. 4 New Shaft prior to rehabilitation in 2003

c. The No. 4 New Shaft area after rehabilitation in 2005

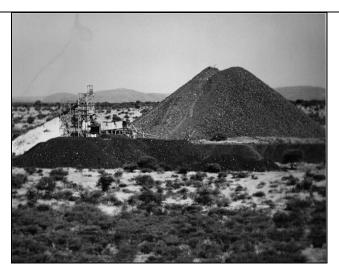
Figure 5. Recontouring of old waste rock dumps at Schildpadsnest.

a. The Magazine No.
1 Shaft area at
Zwartkop Chrome
Mine when the mine
was in operation.

b. The Magazine No. 1 Shaft area prior to rehabilitation in 2003 (summer)

c. The area following recontouring in 2005 (winter).

- Old waste piles 12 areas were identified where large waste piles existed and were required to be profiled to an acceptable height and slope. A further condition stipulated was that all concrete and brick rubble, along with all old tramp metal and steel wire cable scrap, be buried within the areas to be covered during this waste pile profiling. A total volume of some 226 000 m³ was estimated to require bulldozing and profiling in this manner (Fig. 5).

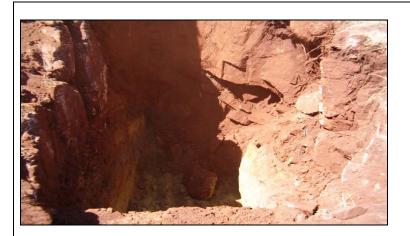
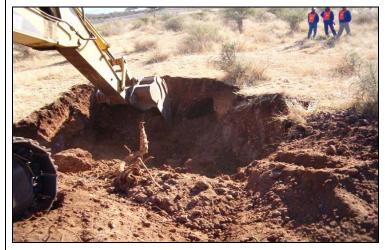
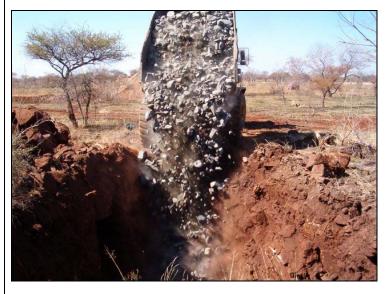
Figure 6. Rehabilitation of sinkholes at Schildpadsnest.

a. A sinkhole in undermined land before the rehabilitation process commenced.

b. Excavation of the sinkhole

c. Backfilling the excavation with waste rock from the abandoned waste rock dumps.

- Sinkholes A total of 48 sinkholes were identified, 28 being along the outcrop position of the Magazine or Main (LG6) seam this seam having been the main ore supply source during the life of the mine, and where the underground workings had been regularly holed through to surface. All were required to be opened up, side slopes made safe to an angle shallower than the natural angle of repose, and then the bottom "throat" plugged with large fragment size waste rock and concrete rubble, together with old steel wire cables scraper rope, to act as a mat, prior to the sinkhole being backfilled, mounded and profiled such that the fill material covered a surface area at least twice the size of the original surface subsidence (Fig. 6).
